# THE CULTURAL LANDSCAPE OF JACANA

## VOLUME II PART 10

SITE STABILIZATION AND PRESERVATION

ARCHAEOLOGICAL INVESTIGATIONS OF SITE PO-29  
MUNICIPIO DE PONCE, PUERTO RICO

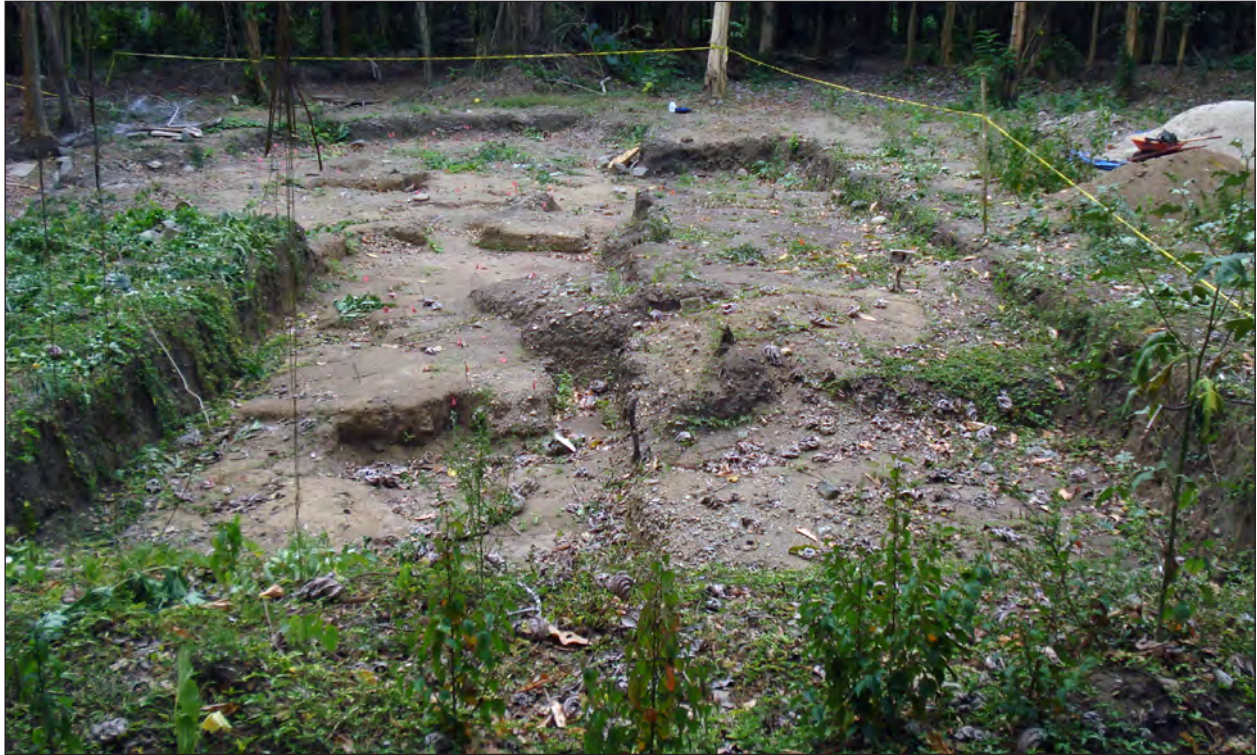
Figure 6.  
T12 Block Area Prior to Stabilization Efforts

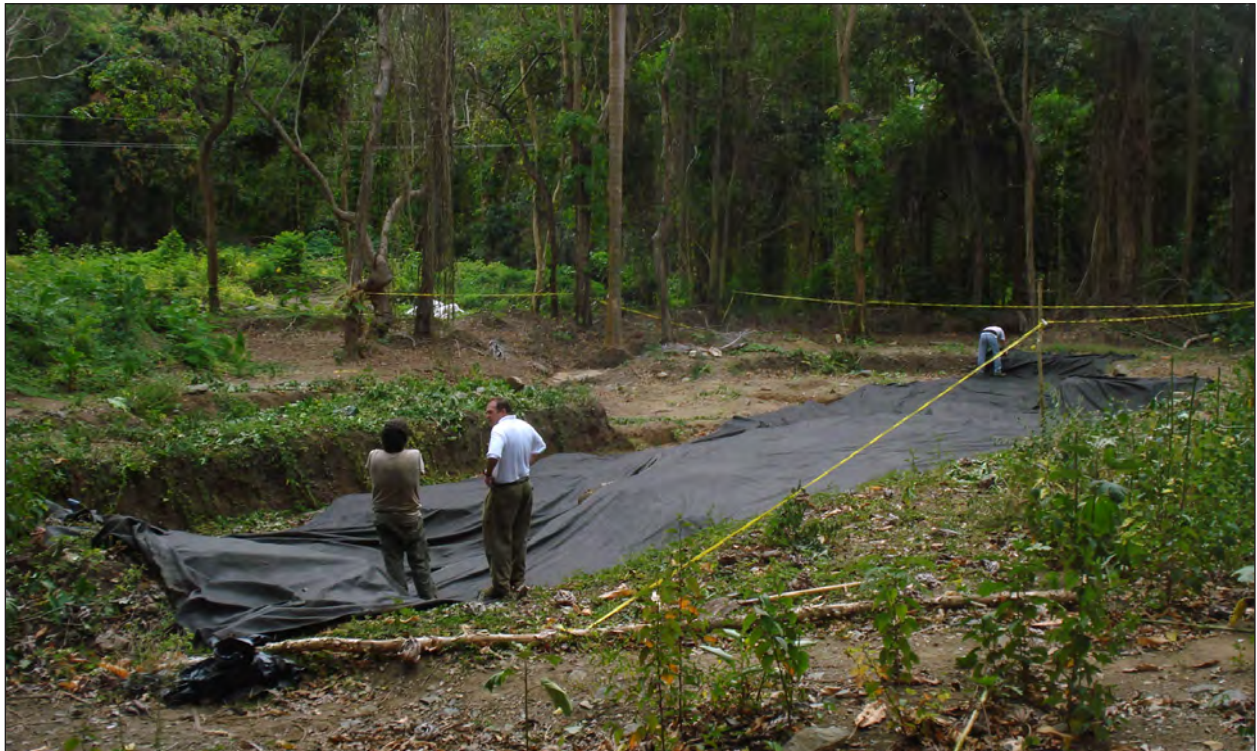
Figure 7.  
Fabric Installation in Block T12

TerraTex N04 fabric was purchased from Puerto Rico Wire in rolls 12 feet wide by 200 feet long. To apply the fabric, New South Associates' field crew rolled fabric across excavation surfaces and over mounded areas such as the back dirt piles, cutting the fabric into segments with the length and width needed to cover each area. Excavation units and deep features within block surfaces were first lined with a separate covering before the block surface was covered. Where units/features had recovered stone cobbles, these were placed back in the excavation following lining and the block surface geotextile fabric was then spread over the block.

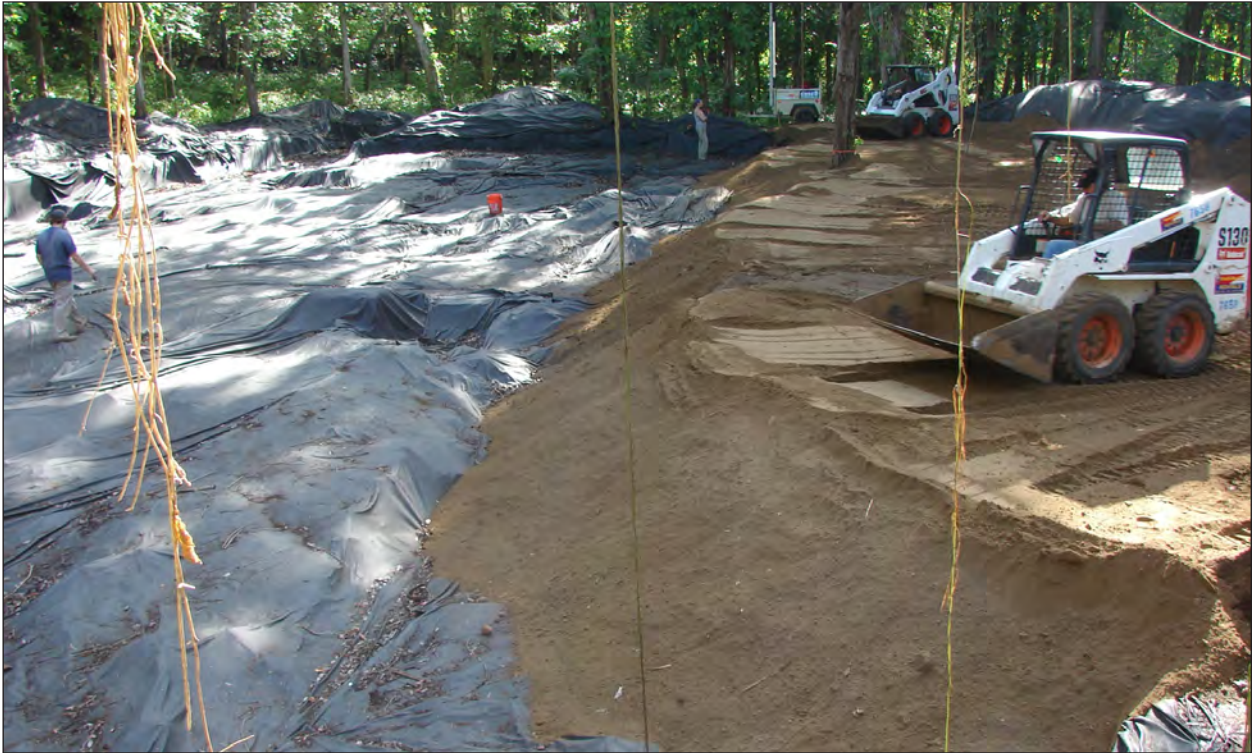
Figure 12.  
Filling in Block F

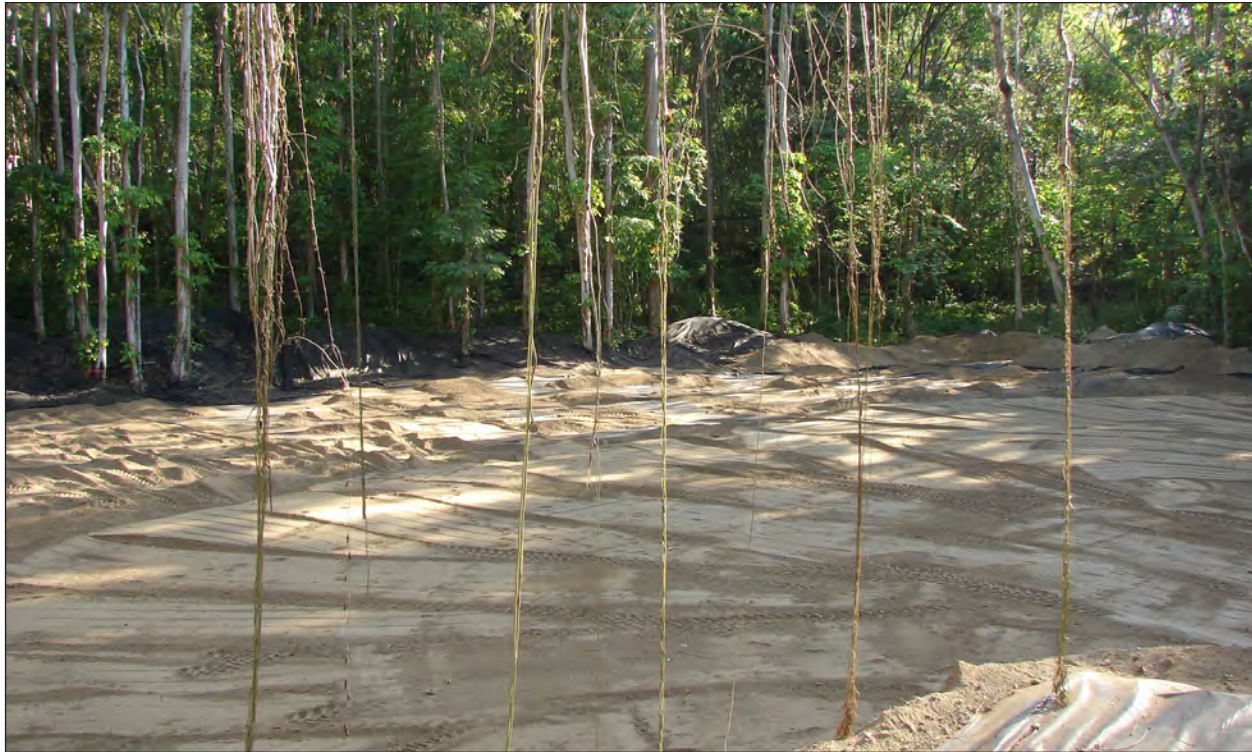
Figure 13.  
F Block Filled

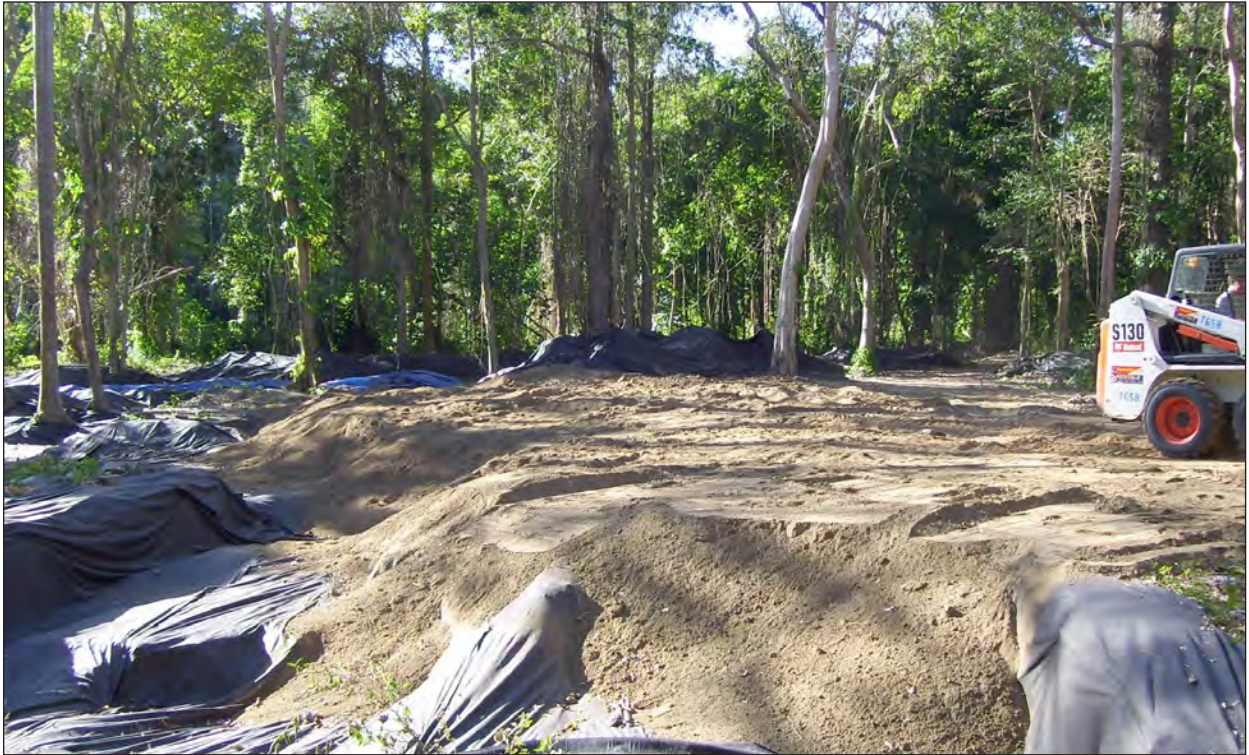
Figure 14.  
T12 Block Being Filled

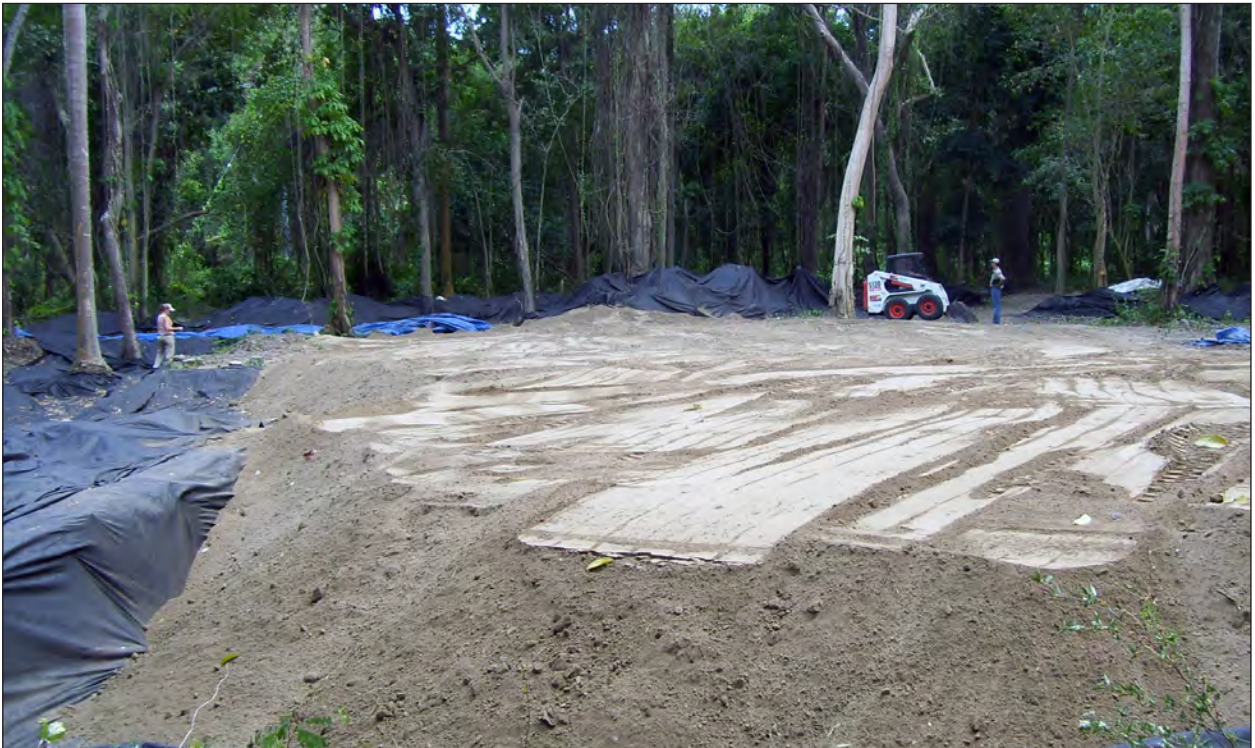
Figure 15.  
Block T12 Filled

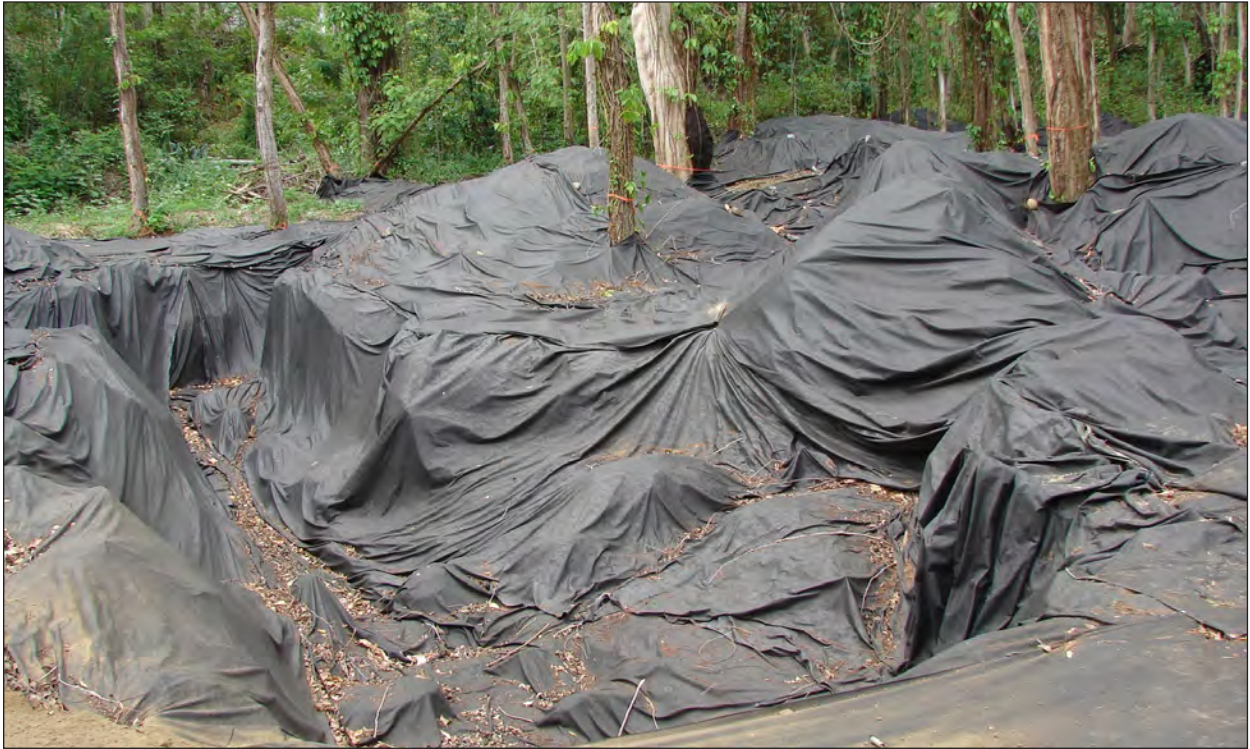
Figure 16.  
East Border Trench with Geo-Textile Material

Trenches were covered using a slightly different process. Fabric sheets were cut to the length of the trench and to a width wide enough to cover the trench floor and borders. Fabric was then laid on the floor and tacked to the borders. Separate segments were cut to cover the trench end borders. Trench fabric overlapped the tops of the borders onto the adjoining ground surface and was secured to the surface, to prevent the fabric from slumping into the trench. These procedures were employed for the geomorphological survey trenches, the midden mound trench, and the east, west, and south borders of the batey trenches. A slightly different procedure was followed for the north border trench.

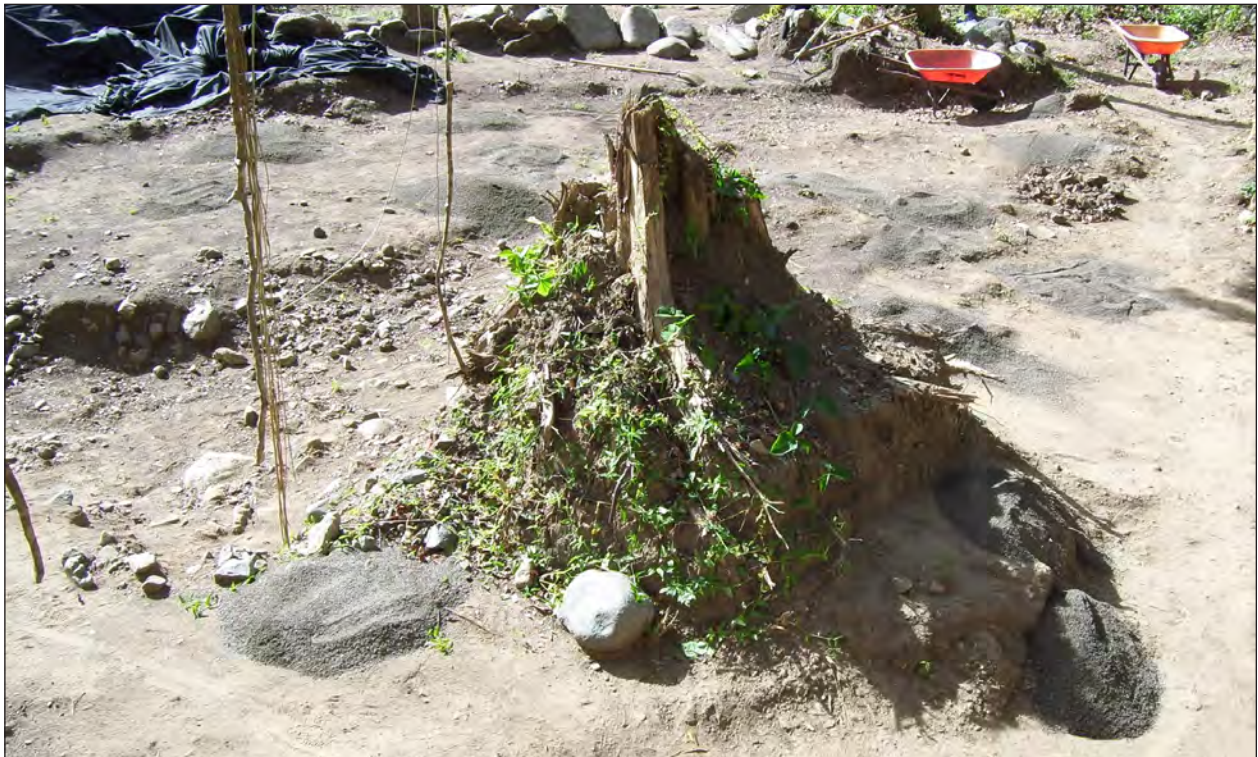
Figure 17.  
Burials In Block H Capped with Gravel

Burials, when present on site surfaces, were covered with gravel obtained from the river's edge. Known burials were provided with gravel caps in Block H (where 27 burials were located), in Block F, and in the trench within the midden mound. The gravel cap prevents the possibility of any human bone coming in contact with the fabric, which will prevent bone from adhering to the

fabric. The use of the gravel caps also distinguishes burial location, so that archaeologists at work in these areas in the future may recognize where burials are present after removal of the geo-textile fabric.

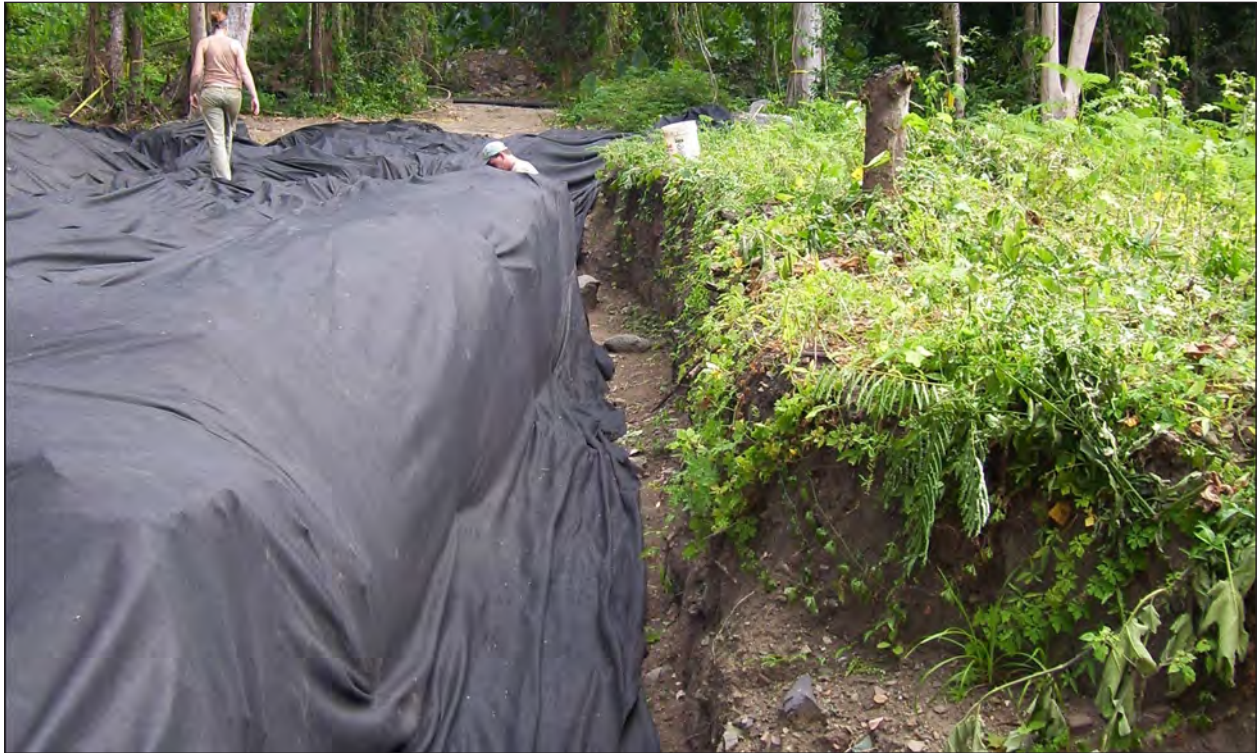
Figure 18.  
Block H Covered with Geo-Textile Fabric

As fabric was applied to each block, sheets were overlapped by 6-12 inches to ensure that the seams between fabric sections remained covered after backfilling. The overlaps were then secured with two-inch zinc roofing tacks. Once a block surface was covered, fill material was brought onto the site and the block was filled. Geotextile fabric was also placed over all of the excavation backdirt piles.

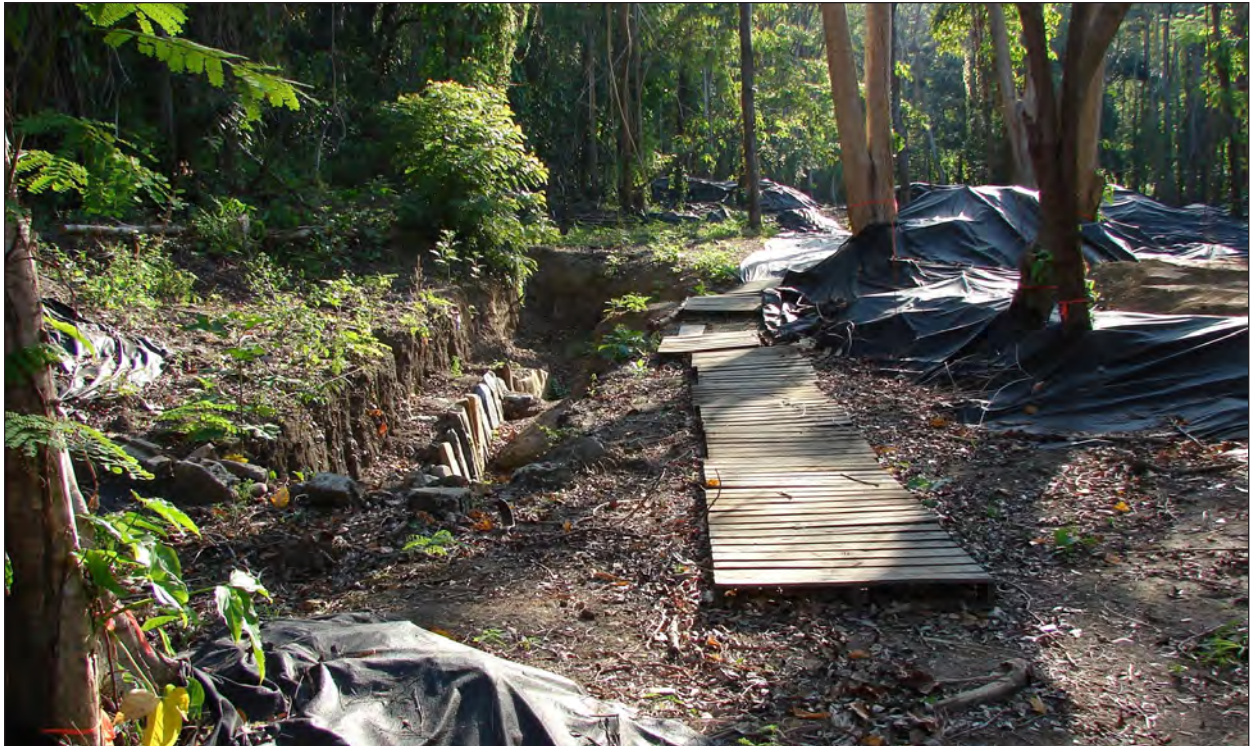
Figure 23.  
North Border Area Prior to Stabilization

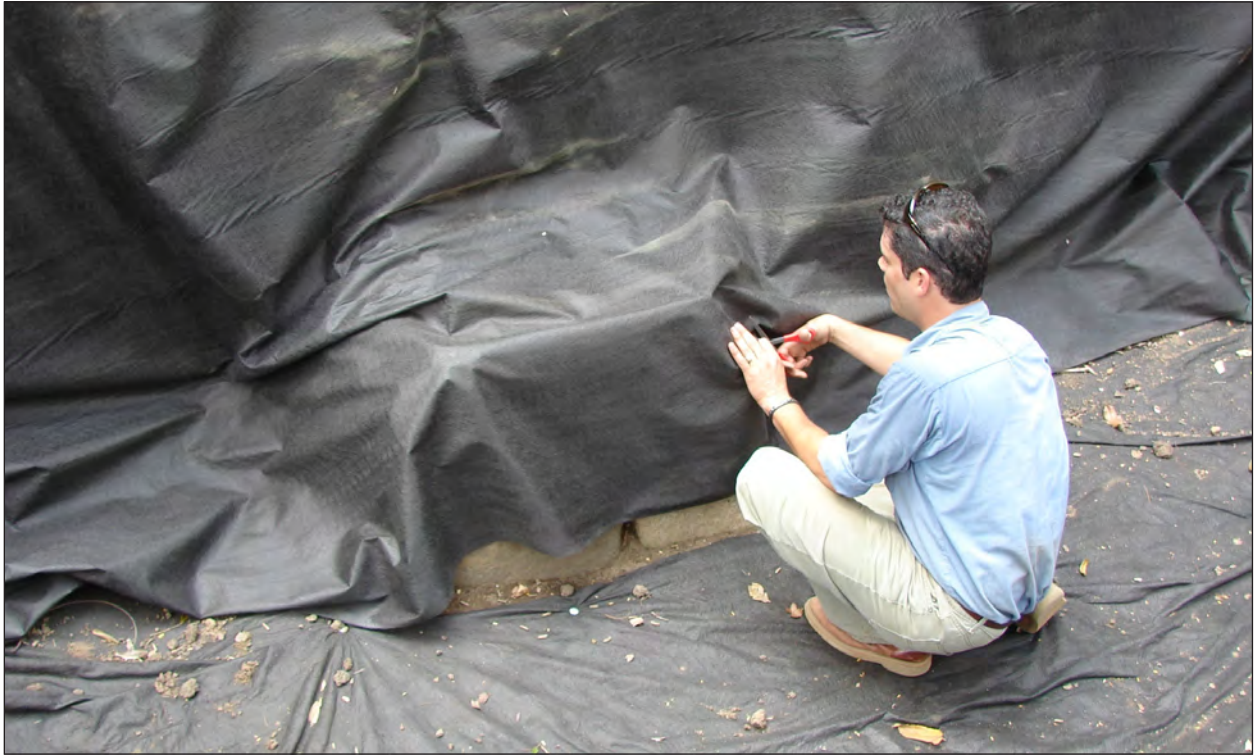
Figure 26.  
Field Supervisor Nate Mountjoy Cutting Fabric from Around Petroglyph Stones

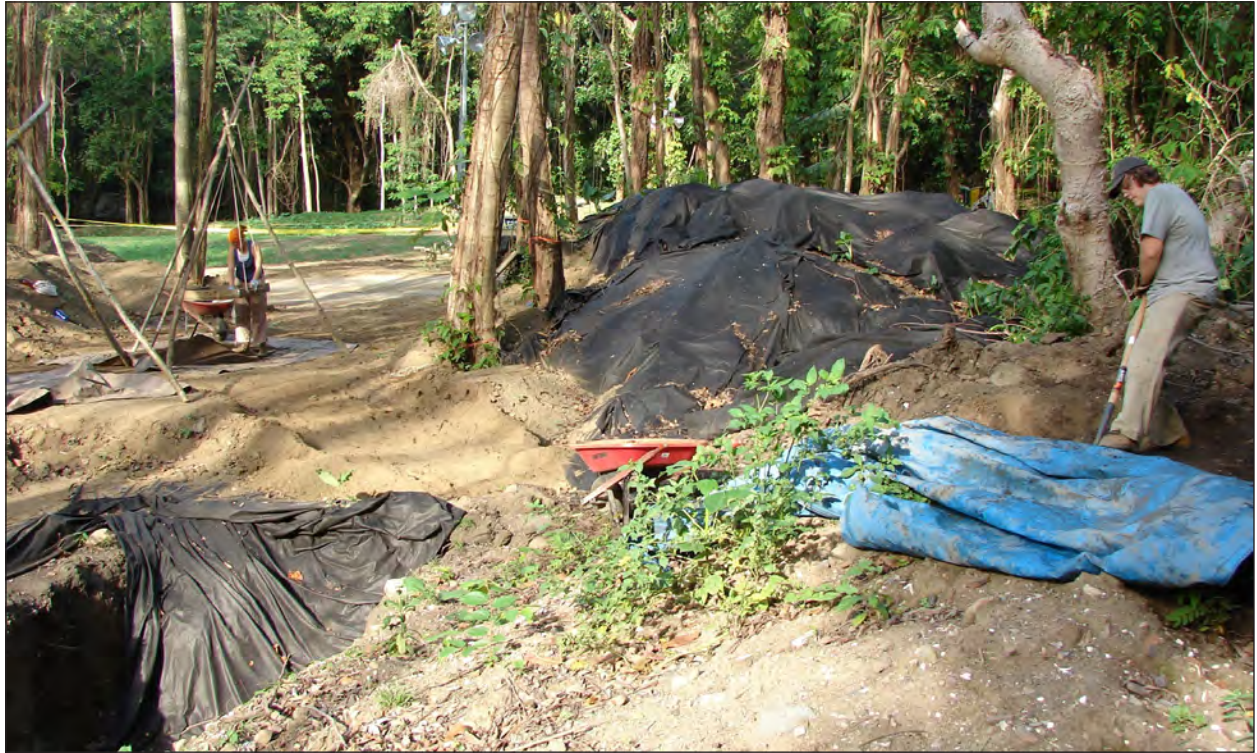
Figure 30.  
Screening Backdirt for Fill to Use as a Buffer Between Fabric and Petroglyph Stones

Dr. Agnew advised that the best procedure was to use soil from the original site excavations to form a barrier between the geotextile fabric and the petroglyph stones, to keep the fabric away from contact with the stones and to avoid introducing new chemical elements to the stone's surfaces.

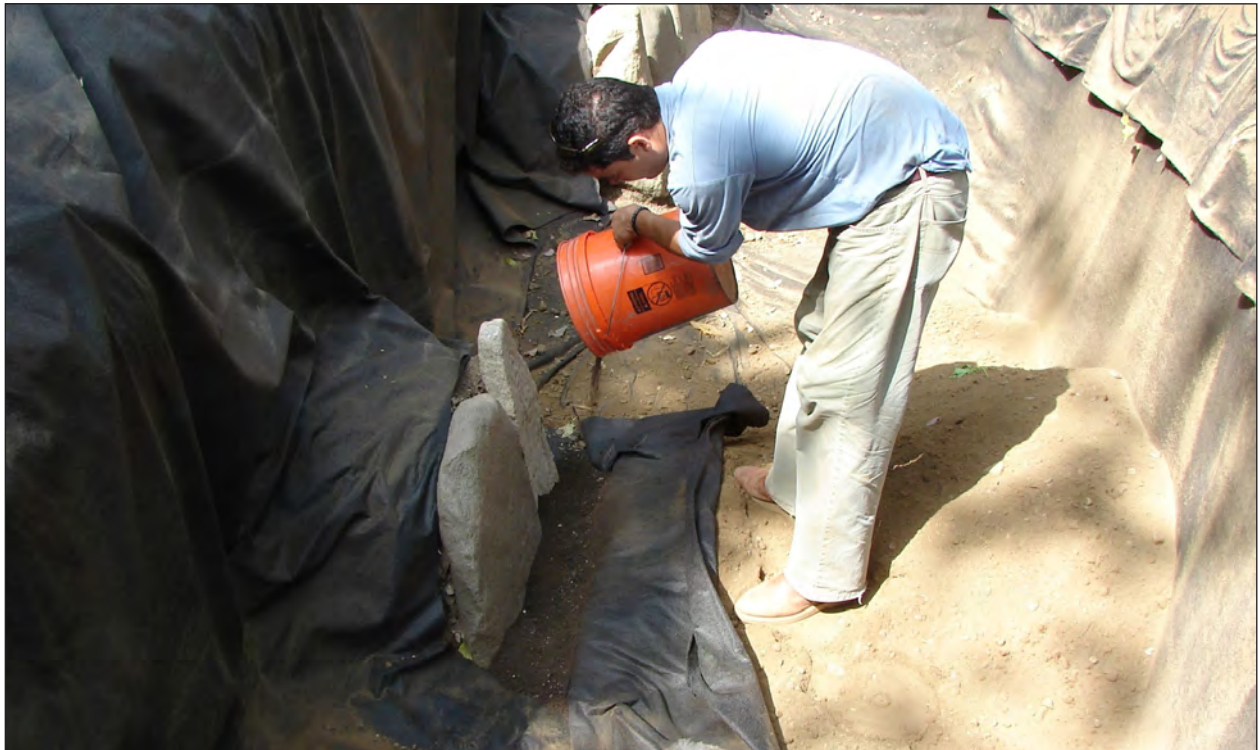
Figure 31.  
Placing Cleaned Fill Between Petroglyphs and Fabric

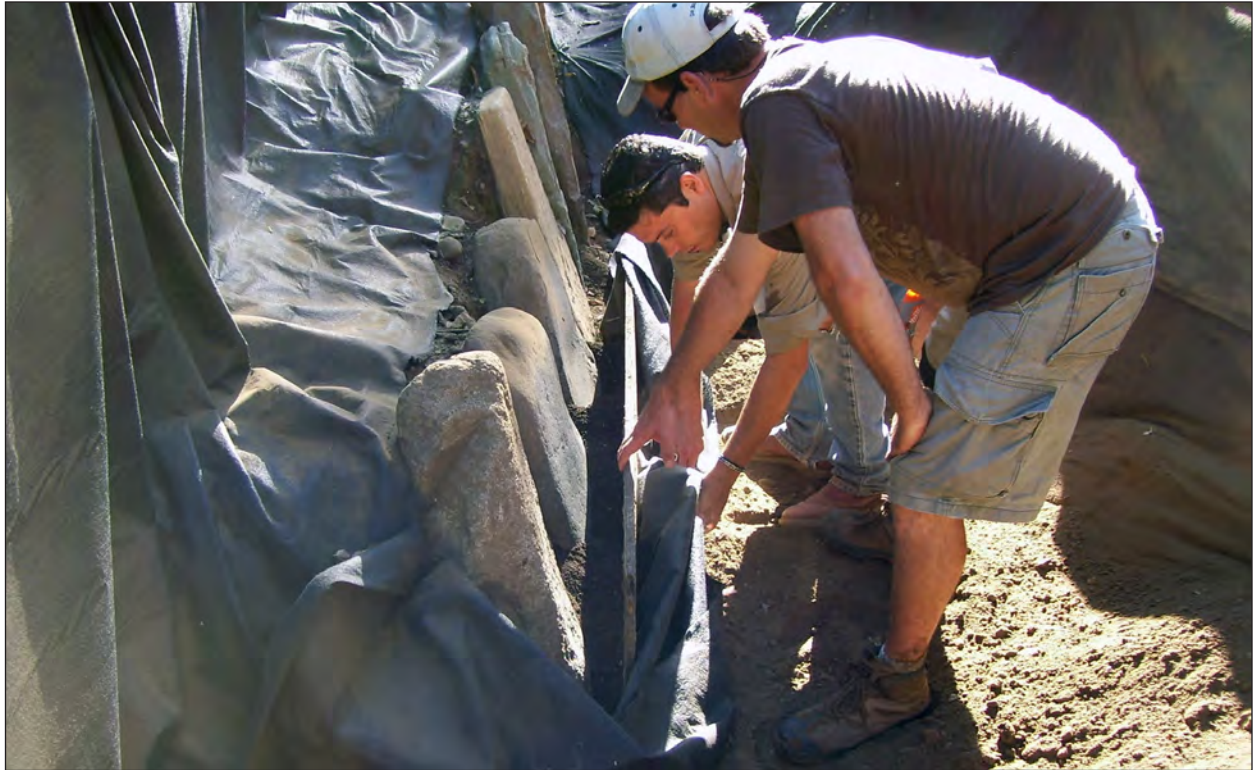
Figure 32.  
Using Board to Compact Fill Around Stones

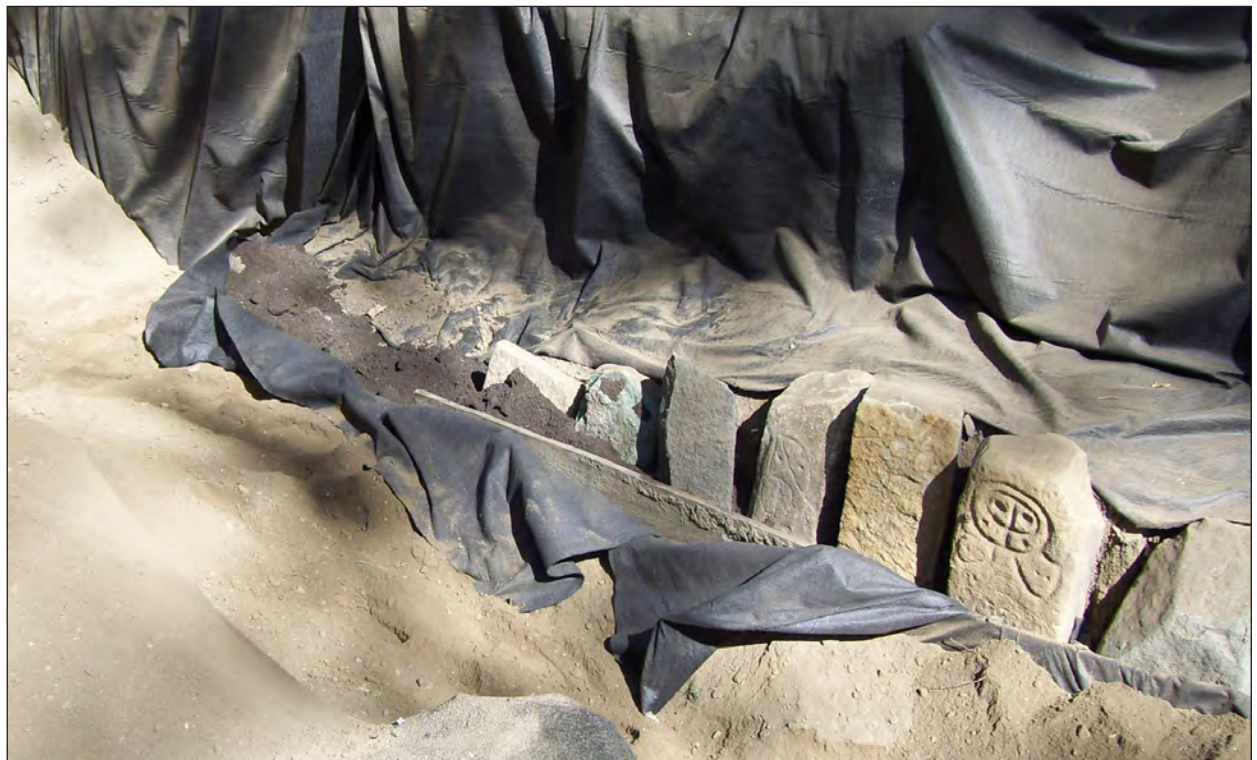
Figure 35.  
Capping Stones at West End of North Border Trench with Cleaned Backdirt Fill

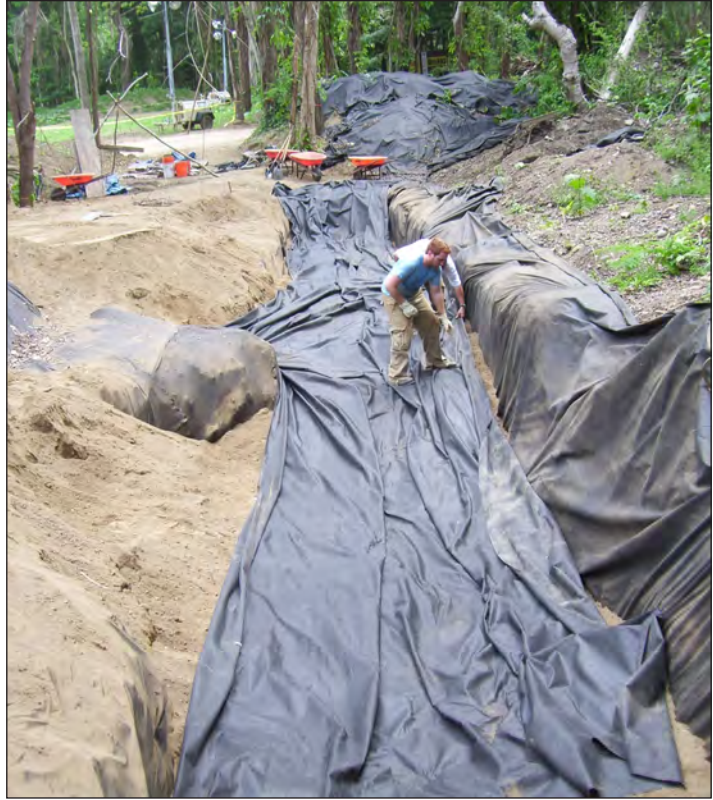
Figure 38.  
Placing Geo-Textile Fabric Barrier over the Surface above the Capped Stones

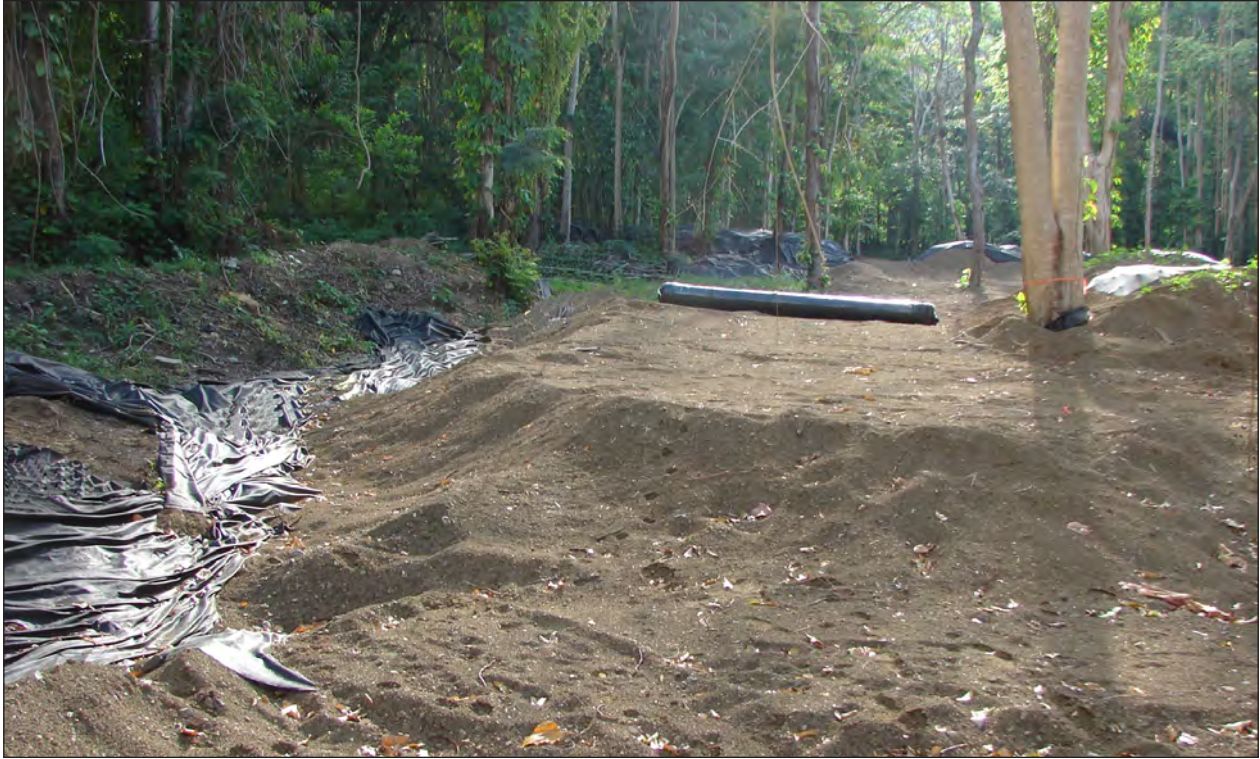
Figure 42.  
Building Mound over North Border Trench Location

these concerns, New South Associates recommended that additional fill material be placed over the north border trench's location to bring its surface to the same height as the surrounding back dirt piles.

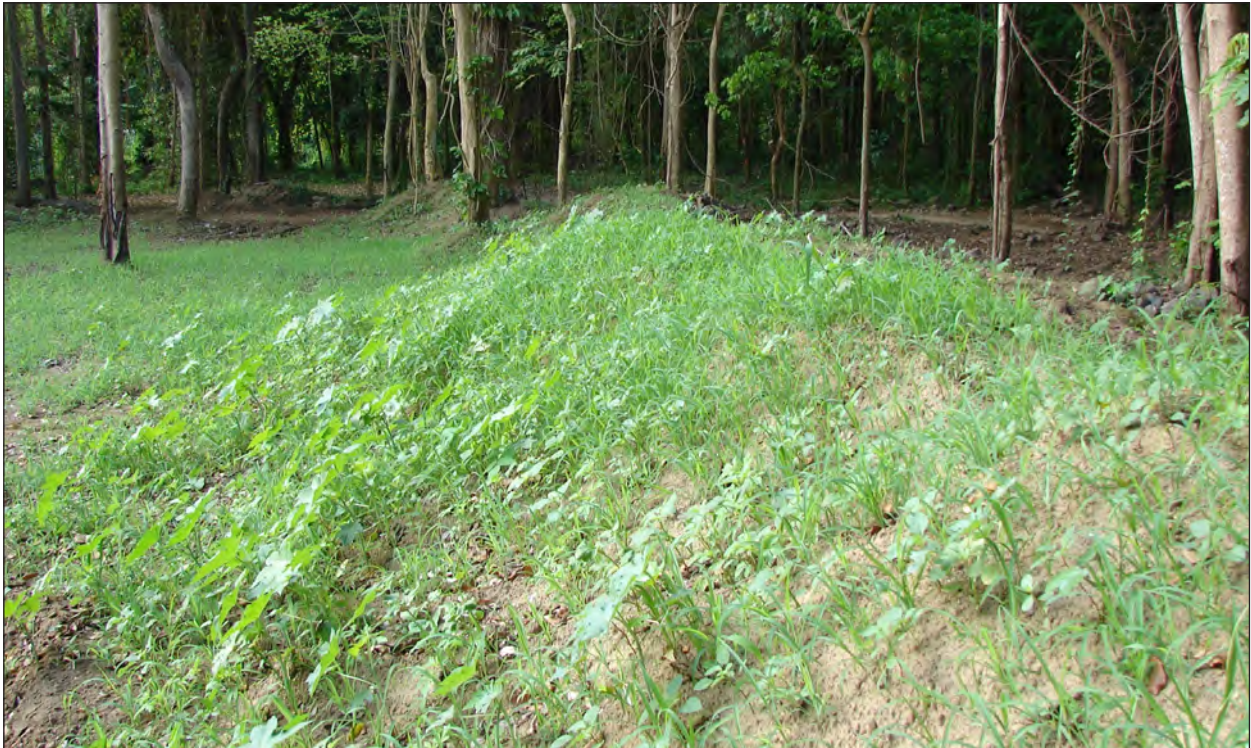
Figure 43.  
Revegetation in Progress

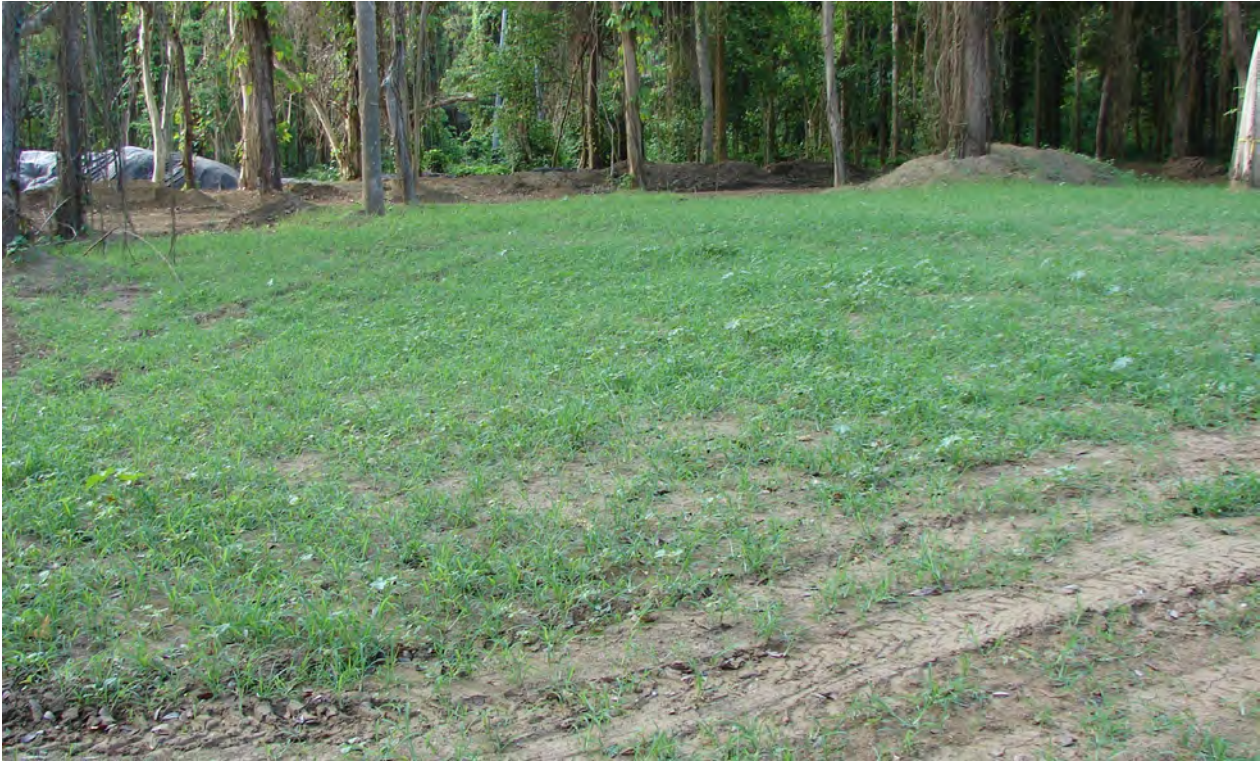
Figure 44.  
Block T12 Vegetation as of Early May 2008

Long-term preservation of the site would benefit from the removal of acacia trees growing on the site. Acacias have extensive and aggressive root systems with destructive properties; in Puerto Rico, they are known as *matafincas*, the property killers. Acacia roots will damage archaeological surfaces and features and hence it is our recommendation that the acacias be cut down and future acacia seedlings pulled to limit their growth on the site.
